## CASE REPORT

# Integrity failure in Riata and Riata ST defibrillator leads: An ongoing problem<sup>☆</sup>

João Madeira<sup>\*</sup>, Leonor Parreira, Pedro Amador, Luís Soares

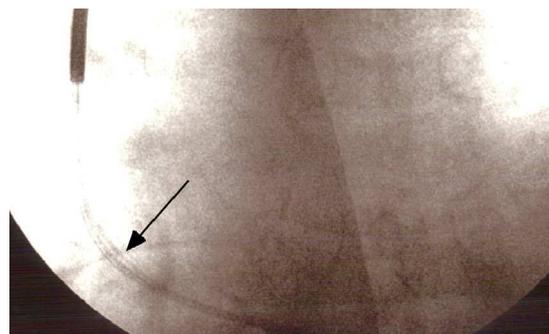
**Figure 1** Fluoroscopy in posteroanterior view showing the externalized conductor (arrow) outside the shadow of the catheter in the region of the right atrium.

Eighty-seven months after implantation the elective replacement indicator (ERI) was reached and pulse generator replacement was accordingly scheduled. Fluoroscopy performed prior to replacement to verify lead integrity revealed an externalized conductor visible outside the shadow of the lead (Figure 1).

All of the parameters testable by the programmer were normal; this model does not measure the impedance of the high-voltage shock circuit. Careful observation of the image showed that the externalization was relatively slight, no loops or angulations being visible, and so a conservative approach was adopted, initially only replacing the pulse generator. During the intervention, after generator replacement, the high-voltage circuit impedance was measured and the intracavitary electrograms (RV-generator, superior vena cava [SVC]-generator, RV-SVC) were subjected to lengthy and meticulous examination, which showed them to be normal. Accordingly, as there was no evidence of electrical dysfunction and the new pulse generator had the ability to perform periodic tests of shock impedance, it was decided to keep the original lead and to conclude the intervention. Defibrillation testing was not considered appropriate. Early detection of dysfunction was programmed and the patient and his family were advised what to do if the ICD's vibratory patient notifier was triggered.
