## IMAGE IN CARDIOLOGY

# Looking in the mirror: An unusual optical coherence tomography image

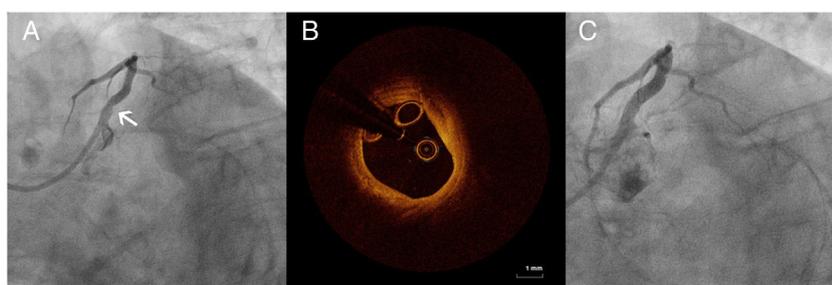
in the LAD. Withdrawal of the jailed D1 guidewire caused a deep intubation of the guide catheter into the LAD. The subsequent angiogram was notable for a suspicious haziness proximal to the stents (Figure 1A, arrow). We decided to perform optical coherence tomography (OCT) of the LAD. However, the catheter did not pass further than the proximal

**Figure 1** (A) Angiography showing a suspicious haziness proximal to the stents (arrow); (B) optical coherence tomography image of the proximal left anterior descending artery (proximal to the stent), with a suspicious circular image; (C) final angiographic result, after angioplasty with a 3.5 mm×18 mm drug-eluting stent proximal to the previous stents.

segment, showing a conspicuous circular image (Figure 1B). Meanwhile, the intravascular ultrasound catheter was able to progress and did not show the image, only malapposed struts. Angioplasty proximal to the previous stents was performed with implantation of a 3.5 mm×18 mm DES, with a good final angiographic result (Figure 1C). In subsequent OCT images the circular image had disappeared.

We postulate that the intubation of the guide catheter during retrieval of the jailed guidewire damaged the proximal stent struts. Thus, the circular OCT image was of the OCT catheter itself, which was folded by attempts to pass
