## IMAGE IN CARDIOLOGY

# Vena cava filter migration after magnetic resonance imaging

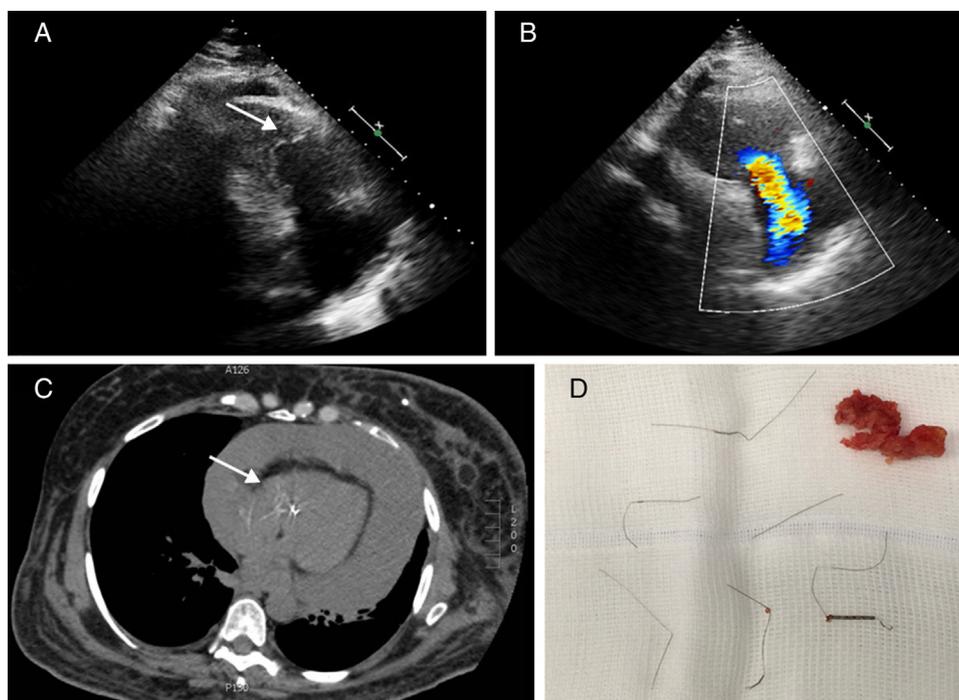
**Figure 1** Echocardiogram showing hyperechoic linear images in the right chambers (A) and severe tricuspid regurgitation (B); chest computed tomography demonstrating intracardiac metallic fragments (C); thrombus and IVC filter fragments removed (D).

Advances in magnetic resonance imaging (MRI) over the past two decades have led to it becoming an increasingly attractive imaging modality. With the growing number of patients treated with permanent implanted or temporary cardiovascular devices, it is becoming ever more important to clarify safety issues with regard to MRI examinations in patients with these devices. A 57-year-old woman was admitted to the emergency department with a one-month history of progressive anasarca. Her medical history included subarachnoid hemorrhage and a deep vein thrombosis in the same hospitalization period, treated with inferior vena cava (IVC) filter placement (ELLA<sup>®</sup>, Hradec Králové, Czech Republic). The initial echocardiographic assessment showed hyperechoic linear images in the right chambers (Figure 1A) and severe tricuspid regurgitation (Figure 1B).

Chest computed tomography confirmed the hypothesis of IVC filter migration, demonstrating intracardiac metallic fragments (Figure 1C). After clinical stabilization with intravenous diuretics, the patient underwent cardiac surgery and thrombus and IVC filter fragments were removed (Figure 1D), in addition to tricuspid valve repair, followed by successful recovery. After a thorough review of the patient's clinical history, it was discovered that she had recently undergone a brain MRI in another institution (about two months before symptom onset), without mentioning implantation of the IVC filter about nine months before. Although this MRI had been performed late, it was probably the cause of IVC filter migration, highlighting the safety concerns with this examination in patients with this device.
