IMAGE IN CARDIOLOGY

Catheter-based closure of multiple residual leaks after percutaneous left atrial appendage occlusion with the Watchman® device

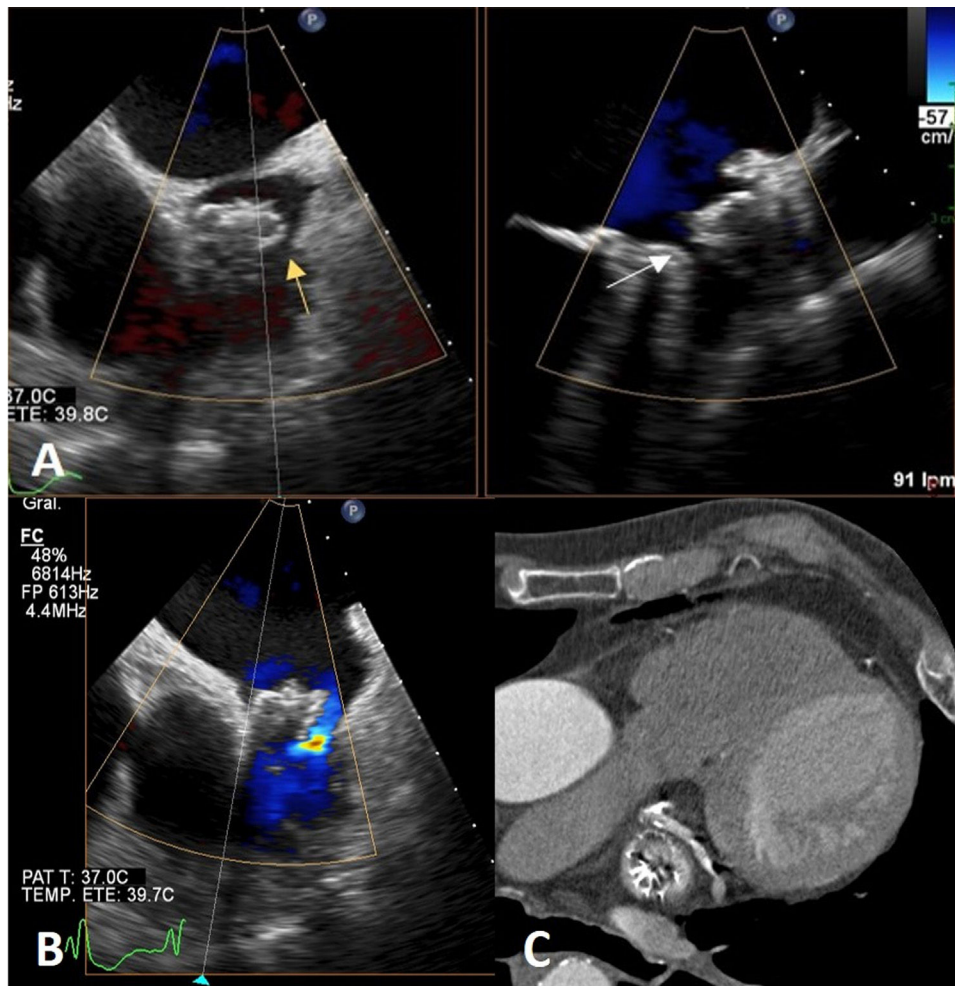
Figure 1 A: Transesophageal echocardiography (TEE) image showing anteroinferior leak (yellow arrow) and posterosuperior leak (white arrow). B: Transesophageal echocardiography with TEE image showing color flow Doppler through the posterosuperior leak. C: Computed tomography image showing leaks on both sides of the device.

significant leaks >5 mm, one on the posterosuperior side and the other on the anteroinferior side (Figure 1, Video 1-2). Due to high hemorrhagic risk, the patient underwent percutaneous closure of the leaks.

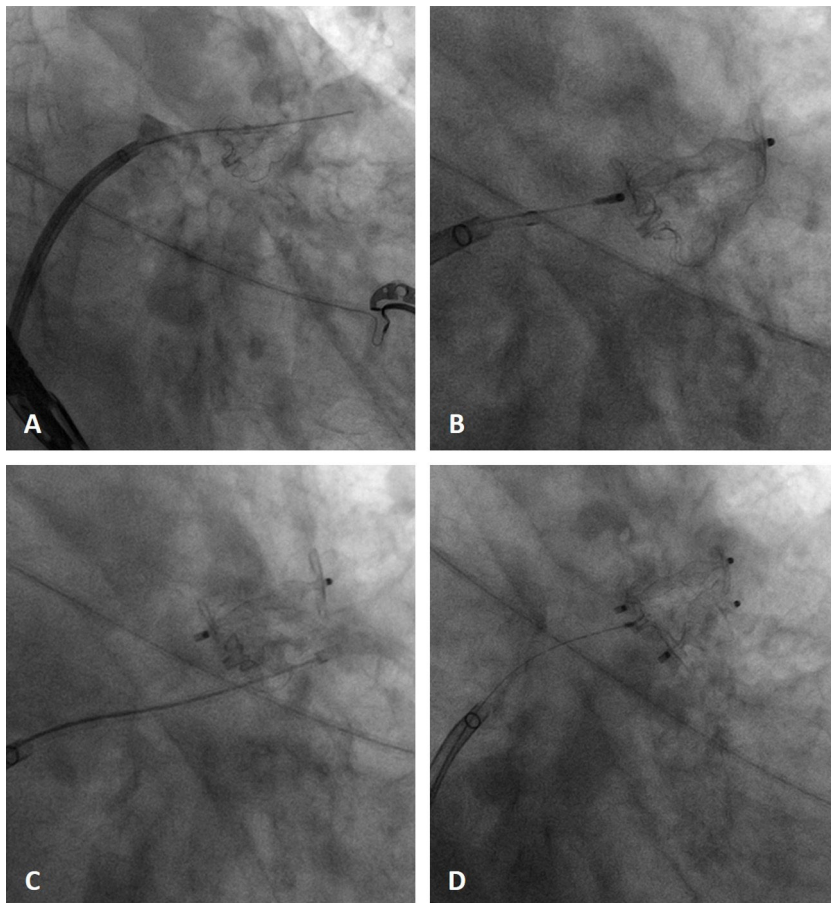
Figure 2 A: Fluoroscopy imaging showing how the guide catheter crossed the upper leak. B: Angiographic image showing the deployment of the first Amplatzer Vascular Plug II into the upper leak. C: Angiographic image showing how the guide catheter crossed the lower leak. D: Fluoroscopy image showing the release of the second Amplatzer Vascular Plug II into the lower leak.

Via right femoral venous access and guided by TEE, transseptal puncture and introduction of a deflectable sheath Agilis 8.5 F Medium Curl (Abbott, IL, USA) in the left atrium were performed. A multipurpose guiding catheter 5F and straight hydrophilic guide (Terumo Europe, Leuven, BE) were introduced through it. Both defects were crossed sequentially and two 12 mm Amplatzer Vascular Plug II (Abbott, IL, USA) devices were released (Figures 2 and 3A and Video 3-6).

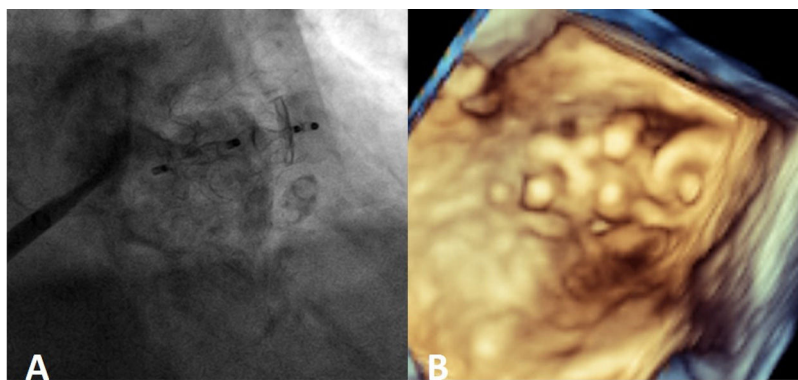
Figure 3 A: Final angiographic result after the release of both devices. B: Final result three-dimensional transesophageal echocardiography image, where we can see all devices.

The procedure was performed without complications, and the patient was discharged the following day with aspirin and clopidogrel. The four-week follow-up TEE showed the devices had been implanted appropriately (Figure 3B).
