A Holy Situation: An Unexpected Complication During a TAVI Procedure

Article type: Snapshot

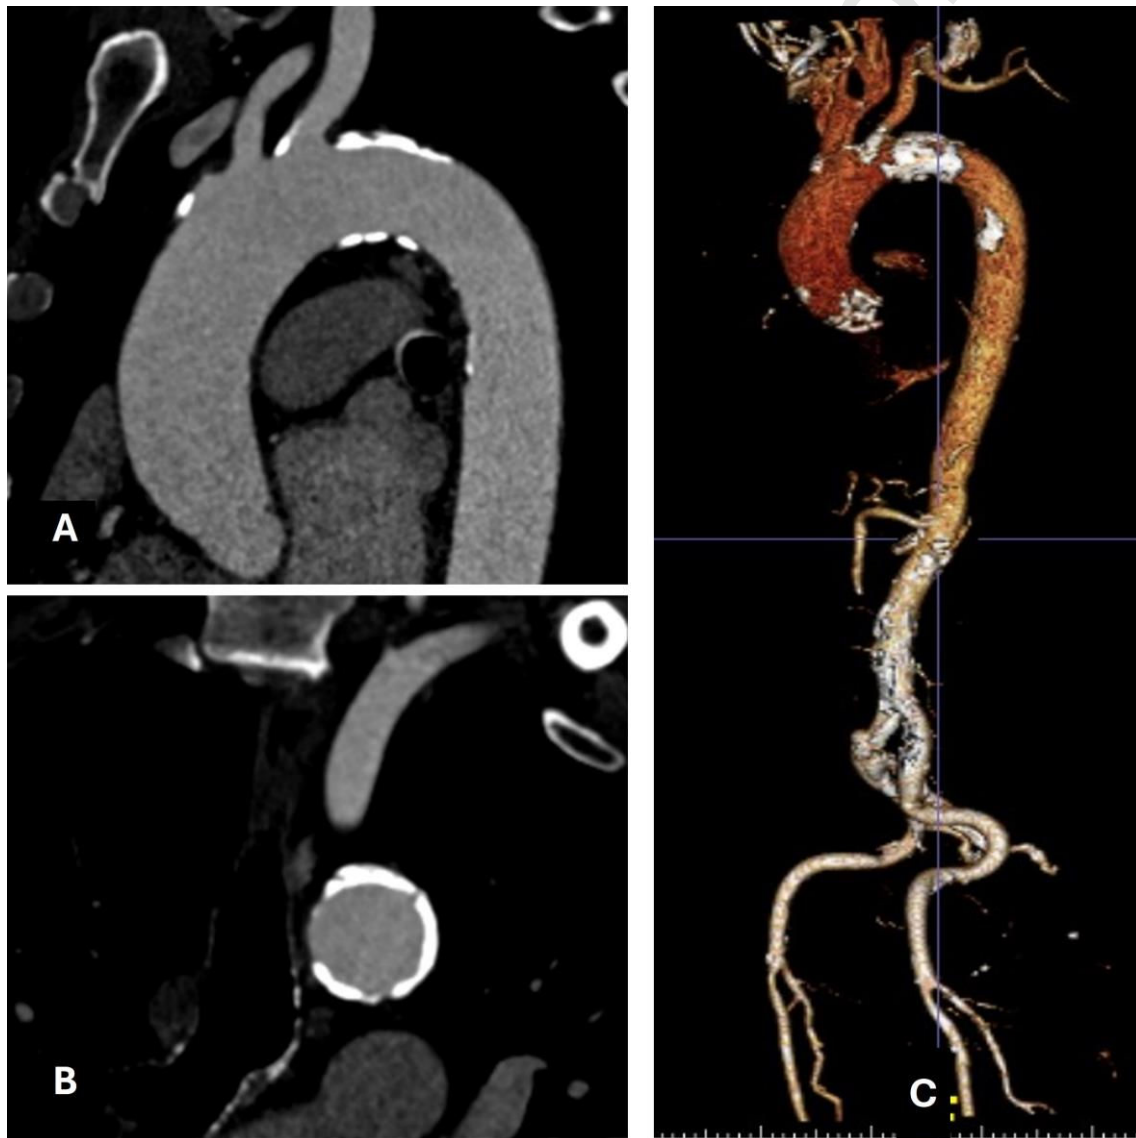
- Figure 1 (A-C): calcification of the aortic arch in the CT scan.

Prior to the procedure, an echocardiography showing a peak velocity in aortic valve of 5 m/s, with mean pressure gradient of 69 mmHg and an area of valve of 0.95 cm² and a computerized tomography (CT) scan demonstrating a tricuspid aortic valve of 24.9 mm diameter according to 78.2 mm perimeter of aortic annulus had been performed. Valvular calcium score was 3645, with a valvular area of 0.8 cm². A severe calcification of the aortic arch was also noted in the CT scan (Figure 1 A-C).

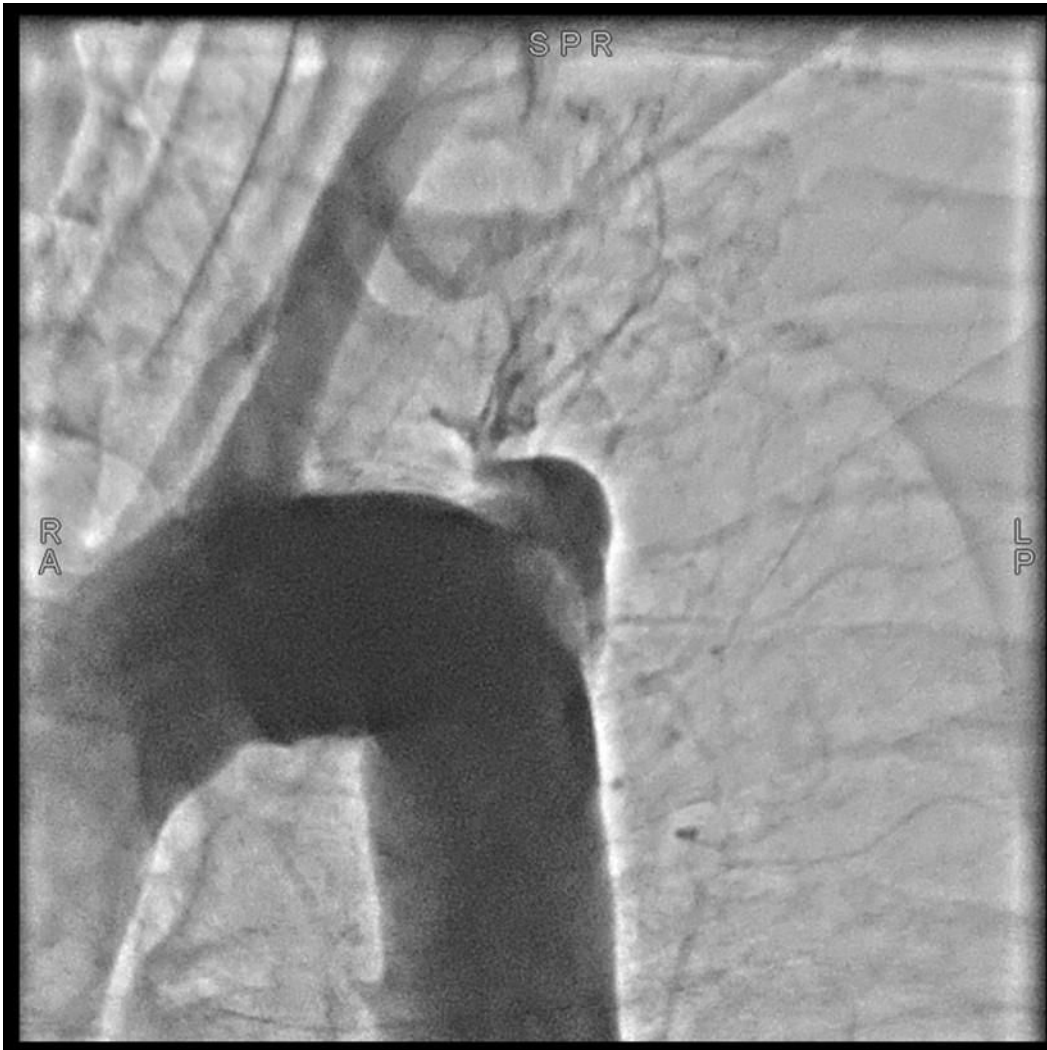
- Figure 2: Aortic rupture at the transition between the arch and the descending aorta

A SAPIEN 3 ULTRA 26 mm was implanted (supplemental video 1). Pre-dilation was performed with a valve balloon dilated to 22 mm. After the implantation of the valve, a moderate residual leak was noted (Supplemental videos 2 and 3). Post-dilation with the same balloon was attempted, encountering difficulty with balloon progression (Supplemental video 4). At this time, the patient presented with hemodynamic collapse and cardiac arrest. Echocardiogram showed no pericardial effusion, excluding annular rupture, and the coronary arteries were patent. While performing advanced life support maneuvers, an aortography was performed, revealing a rupture at the transition between the aortic arch and the descending aorta (Figure 2, Supplemental video 5). Tamponade with a 28 mm balloon was performed and a TEVAR 28 mm was implanted with subsequent dilation using a RELIANT balloon. While resolution of the active rupture was achieved angiographically (Figure 3, supplemental videos 6-8), and despite 55 minutes of resuscitation maneuvers, cardiac rhythm could not be restored.

Aortic rupture is a rare complication of TAVI, occurring in <1% of the procedures, but it is generally catastrophic.^{1,2} Rupture can occur from puncture of the aorta by the delivery catheter when trying to advance around an acute angulation in a tortuous aorta.² A high level of suspicion is needed, and the diagnosis should be considered in any patient undergoing TAVI who experiences hemodynamic instability.^{1,2} It is a life-threatening complication, as it causes rapid onset of hemorrhagic shock. Management options include surgical or endovascular repair (with covered stent grafts).² Despite appropriate interventions, mortality remains high.^{1,2}

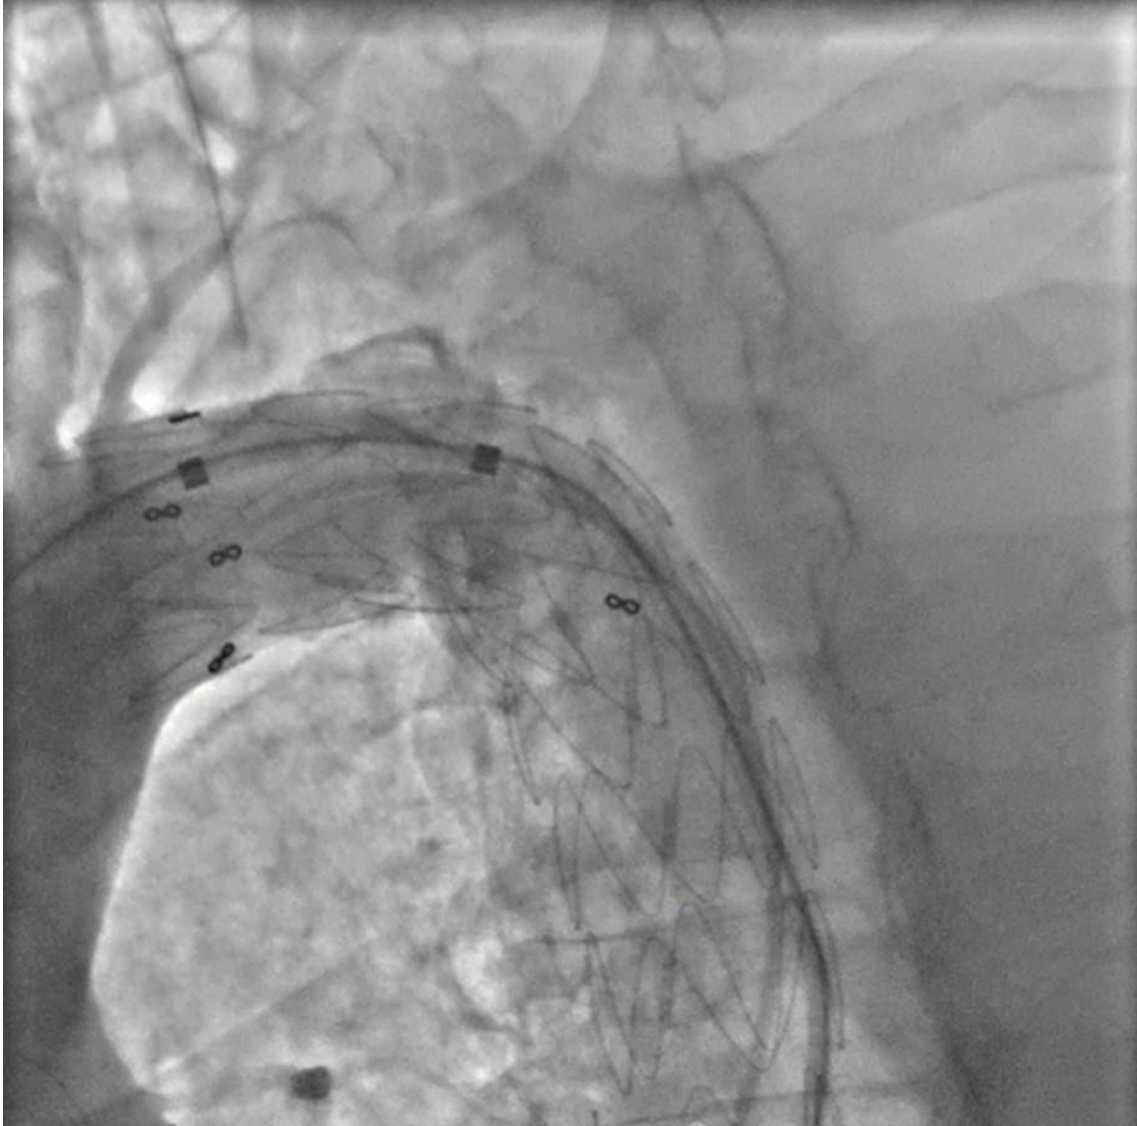
- Figure 3: Angiographic resolution with a TEVAR 28 mm.
