IMAGE IN CARDIOLOGY

Device entrapped in subvalvular apparatus: A surprising result

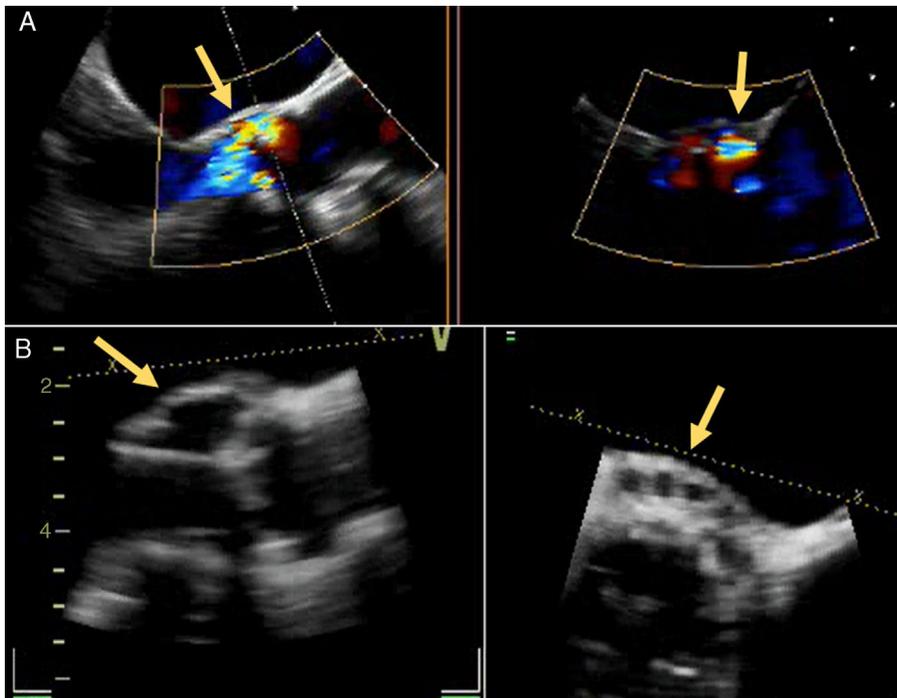
Figure 1 Severe paravalvular leak in the posterior portion of the aortic prosthesis (A, arrow) and pseudoaneurysm with fistulization to the left ventricle and aorta (B, arrow).

A 72-year old woman with a history of mechanical aortic prosthesis since 2010 and early infective prosthetic endocarditis (medical treatment) was hospitalized for acute heart failure in February 2015. Transesophageal echocardiography showed a severe paravalvular leak in the posterior portion of the aortic prosthesis (Figure 1A, arrow) and a pseudoaneurysm with fistulization to the left ventricle (LV) and aorta (Figure 1B, arrow), moderate mitral regurgitation and mild LV systolic dysfunction. Surgery was considered high risk and percutaneous closure of the paravalvular leak was attempted. The procedure was guided by fluoroscopy and transesophageal echocardiography. After confirming the stability of the device (Amplatzer® Vascular Plug II 12 mm/9 mm) and reduction of the paravalvular leak without functional compromise of the mechanical prosthesis

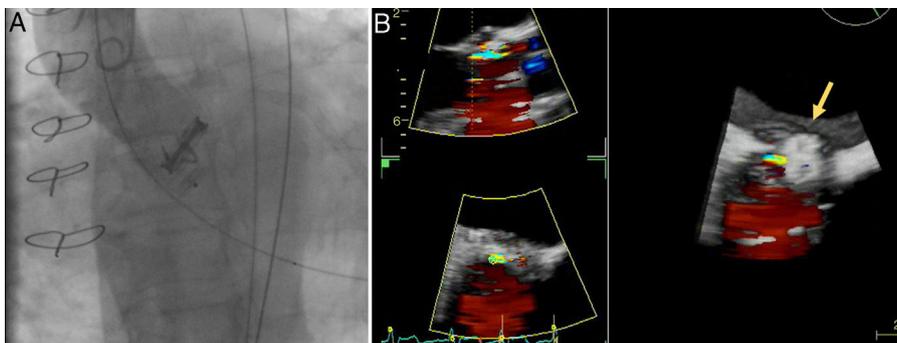
Figure 2 Reduction of paravalvular leak without functional compromise of mechanical prosthesis and confirmation of its stability (A: fluoroscopy; B: transesophageal echocardiography).

(Figures 2A and 2B, arrow), the device was released. Minutes after deployment, the device migrated into the LV (Figure 3A, arrow and Supplementary data online, Movie S1). The device could not be retrieved (Figure 3B, arrow). Echocardiography images showed the device lodged beneath the posterior mitral leaflet, entrapped in the subvalvular mitral apparatus, with no significant compromise of mitral valve function (Figures 4A, arrow and 4B, arrow and Supplementary data online, Movie S2). Follow-up echocardiographies showed the device still in the same position. The patient died of sepsis due to a *Clostridium difficile* infection 58 days after admission (one month after the procedure). This case illustrates a rare and dramatic complication of percutaneous leak closure, but without significant hemodynamic impact on mitral valve and LV function.

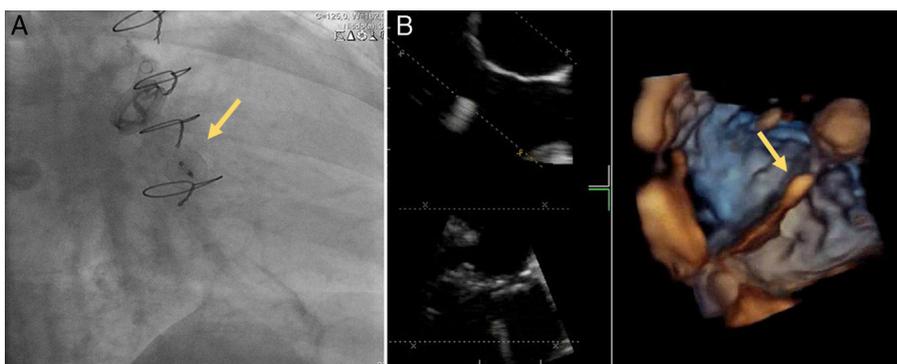
Figure 3 Migration of the device into the left ventricle (A) and attempt to retrieve it with a snare (B).

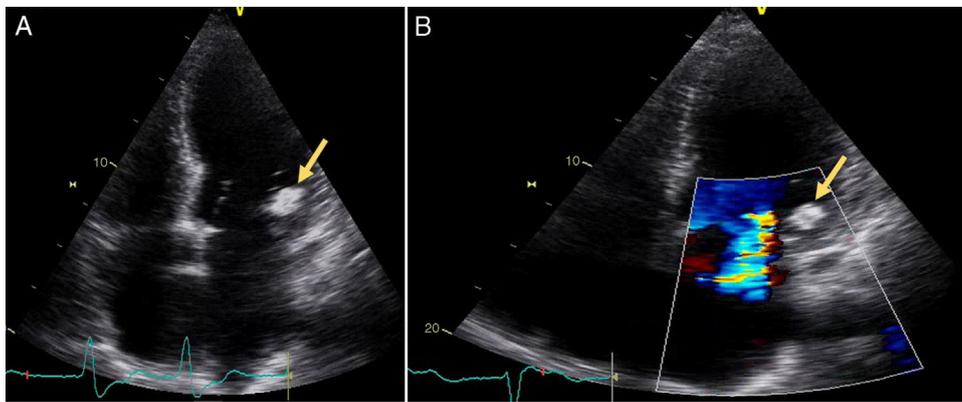
Figure 4 Device entrapped in the subvalvular mitral apparatus (A), with no significant compromise of mitral valve function (B).
