CASE REPORT

Left ventricular pacing with a temporary pacemaker: Case report

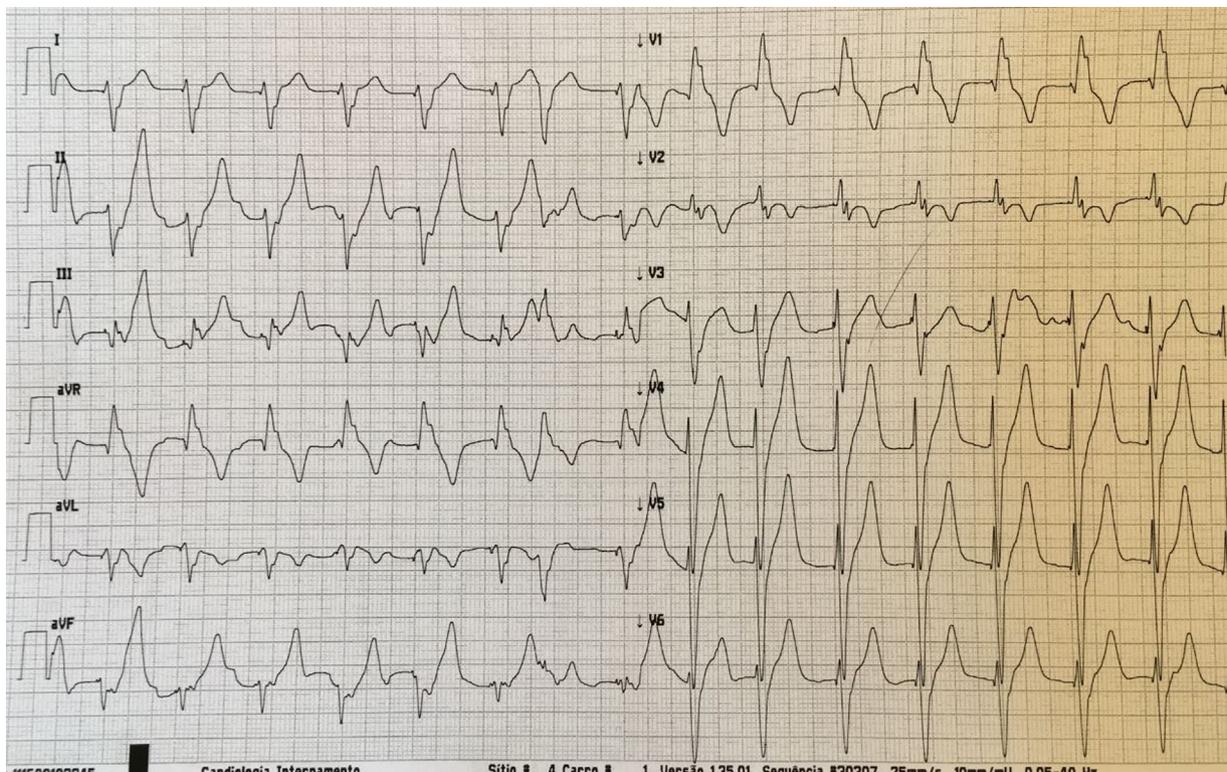
Figure 1 Electrocardiogram showing a paced right bundle branch block pattern.

The patient remained monitored with telemetry, in sinus rhythm and asymptomatic until the next morning, when temporary pacing periods were detected. The ECG showed a paced right bundle branch block pattern (Figure 1), which raised the suspicion of an inappropriate lead position. Bedside echocardiography documented an anomalous course of the lead across the muscular portion of the intraventricular septum, with the tip in the left ventricle (LV) (Figure 2). There was no pericardial effusion and no shunt was detected with color Doppler. Biventricular systolic function was preserved.

rarer. Diagnosis and management can be very challenging. A right bundle branch block pattern on a 12-lead surface ECG is an important clue to the diagnosis, and should immediately raise the suspicion of displacement.² Fluoroscopy is

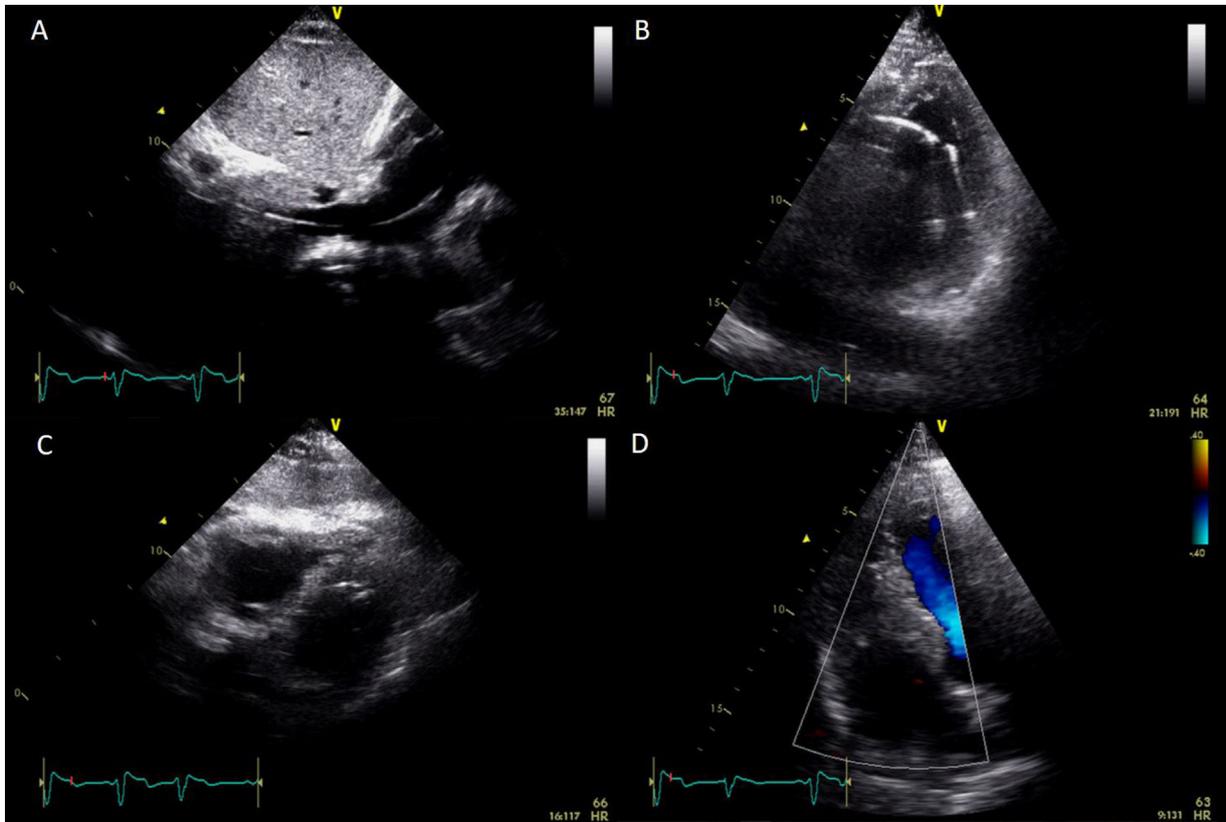
Figure 2 Echocardiogram showing the lead crossing the inferior vena cava and right atrium (A), and its anomalous course across the muscular portion of the intraventricular septum, with the tip in the left ventricle (B and C). No shunt was detected between the right and left ventricles (D).

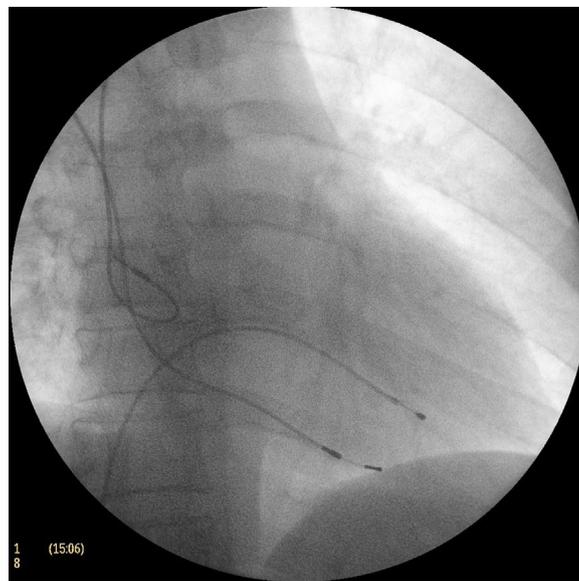
Figure 3 Fluoroscopy, posteroanterior view, showing malposition of the temporary pacemaker lead, with the tip in the left ventricle, and normally positioned right atrial and right ventricular leads of the permanent pacemaker.

through the subclavian vein, with no complications. The course of the temporary lead could be visualized on fluoroscopy across the inferior vena cava and the heart, with the tip in the LV (Figure 3). The left ventricular lead was removed under the surveillance of a cardiac surgeon, the patient remaining hemodynamically stable and without complications.

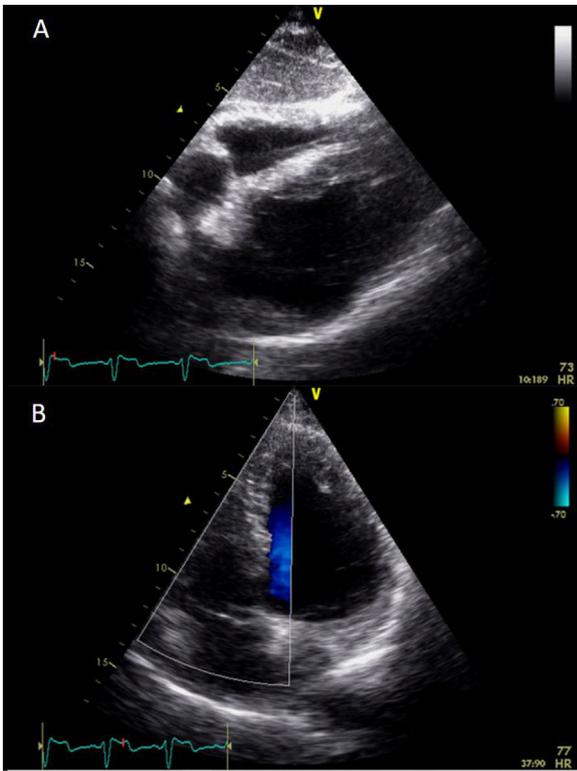
Figure 4 Post-procedure echocardiogram, subcostal view, revealing a well-positioned permanent pacemaker lead (A); no shunt was detected between the right and left chambers (B).

At the end of the procedure, echocardiography confirmed the position of the PM leads in the right chambers, without pericardial effusion. After administration of agitated saline, no shunt was detected between right and left chambers (Figure 4). The patient progressed favorably, remained asymptomatic and was discharged from the hospital the next day. After three months he attended the pacemaker clinic and reported no related symptoms.
