## IMAGE IN CARDIOLOGY

# Infective endocarditis: When an image surprises the echocardiographer

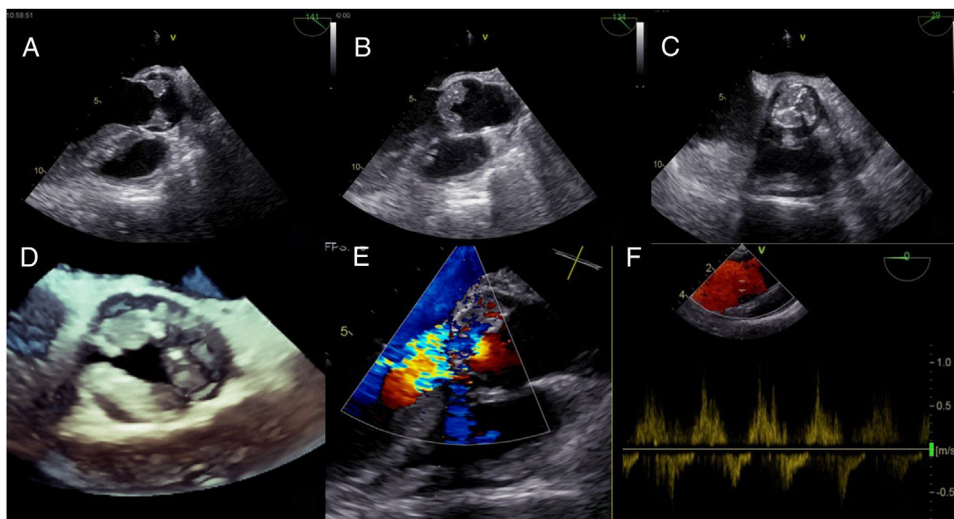
**Figure 1** Transesophageal echocardiography: aortic valve vegetations (A, B) resembling the Mercedes Benz symbol (C, D); severe aortic regurgitation (E) (vena contracta 7 mm) and (F) (holodiastolic reverse flow in the descending aorta).

Lung nocardiosis was diagnosed and he was put on imipenem and trimethoprim-sulfamethoxazole. Despite effective treatment, the patient presented recurrent fever. Transesophageal echocardiography documented exuberant multinodular vegetations involving all cusps of the aortic valve (maximum width 10 mm×12 mm) (Figure 1A and B and

Video 1), in a pattern resembling the Mercedes-Benz symbol (Figure 1C and D), causing severe aortic regurgitation (Figure 1E and F; Video 2). Vegetations were also seen in the non-coronary sinus of Valsalva (Figure 2A, arrow) and on the tricuspid valve (Figure 2B, asterisk). Aortic valve replacement was performed and no vegetations were found on the tricuspid valve. Blood cultures were persistently negative, as were microbiological analysis of the surgical specimen and serology for atypical agents. The patient eventually died due to neurological complications.

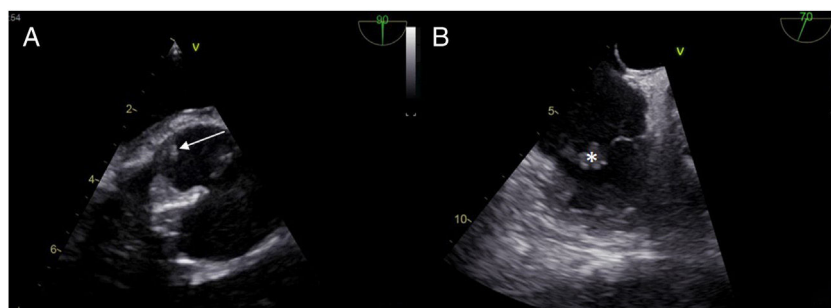
**Figure 2** Transesophageal echocardiogram: small mobile vegetation in the non-coronary sinus of Valsalva (A: arrow) and on the tricuspid valve (B: asterisk).
