## CASE REPORT

# When inappropriate becomes beneficial

José David Arroja\*, Marc Zimmermann

Cardiovascular Department, Hôpital de La Tour, Meyrin-Geneva, Switzerland

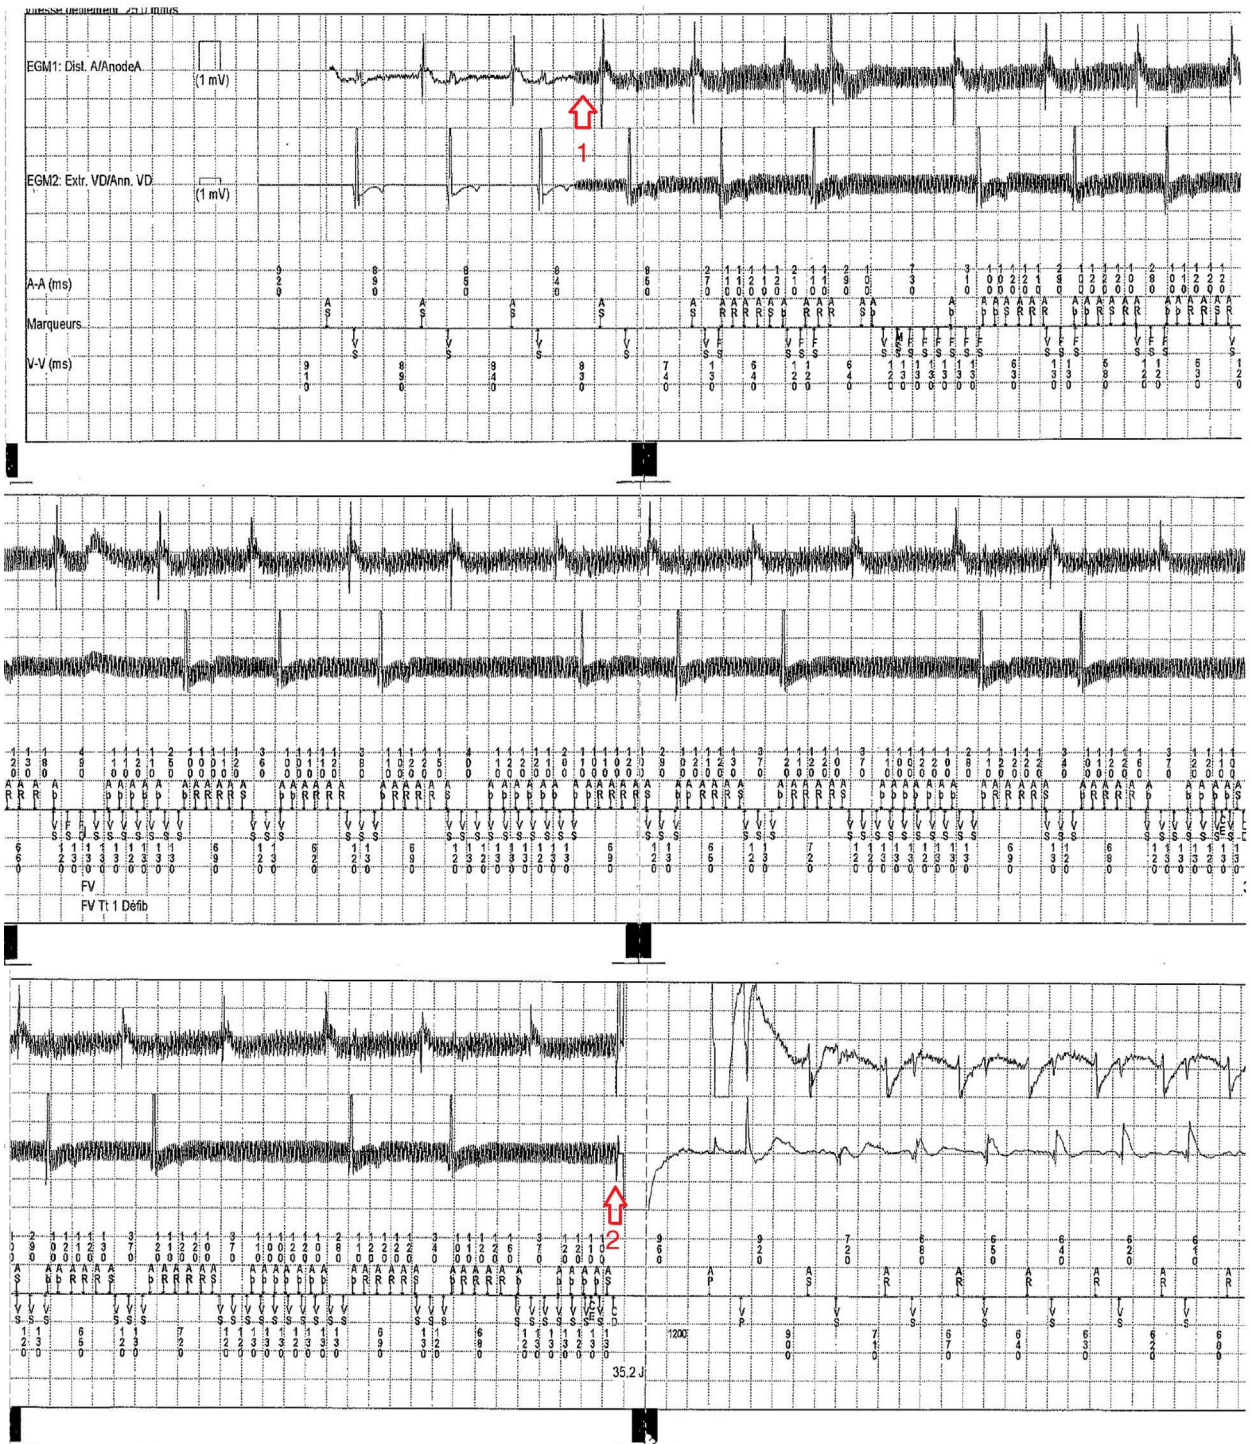
Figure 1 Implantable cardioverter-defibrillator (ICD) electrogram with (1) start of electrical interference and (2) ICD shock delivery and termination of interference.

ICD interrogation revealed the application of a shock 11 seconds after the beginning of continuous high-frequency electrical activity, interpreted as an episode of ventricular tachyarrhythmia by the device.

The review of the ICD electrogram (Figure 1) clearly shows atrioventricular activity with narrow and regular QRS complexes parasitized by high-frequency low-intensity

baseline interference, corresponding to the accidental 50–60 Hz electrical exposure, terminated by the ICD shock delivery. Unlike the case reported by Saguner and Duru<sup>1</sup> in which a shock was avoided by appropriate detection of interference by the ICD's noise reversion algorithm, our patient's device was not equipped with this functionality, and hence was unable to respond adequately, delivering a

35-J shock that probably helped the patient release the electrical source, as noise termination occurred immediately after shock delivery and as the patient himself reported.
