IMAGE IN CARDIOLOGY

## Assessment of bioabsorbable scaffolds by multislice computed tomography angiography

Portuguese Journal of **Cardiology** www.revportcardiol.org

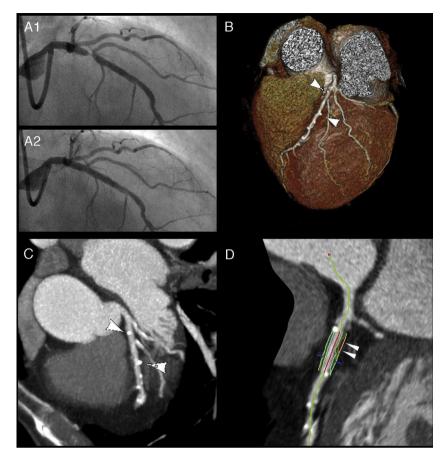
**Figure 1** Coronary angiography, showing significant left anterior descending stenosis (A1) and angiographic outcome after placement of a bioabsorbable scaffold (A2). Multislice computed tomography angiography: volume rendering (B) and maximum intensity projection reconstructions (C), revealing the radiopaque indicators (arrows) at the edges of the scaffold. Virtual histology technique showing the non-calcified atherosclerotic plaque (arrows) excluded by the stent (D).

A 68-year-old man with a history of coronary artery disease was admitted with non-ST-elevation myocardial infarction. Coronary angiography revealed 95% stenosis of the proximal left anterior descending artery (Figure 1A1). The patient underwent percutaneous coronary intervention with implantation of a 3.5 mm $\times$ 18 mm bioabsorbable everolimus-eluting poly(lactic acid) scaffold (Abbott Vascular, Santa Clara, CA) (Figure 1A2). As part of a prospective study, 64-slice CT angiography (SOMATOM Sensation 64 scanner, Siemens, Forchheim, Germany) was performed at the first month follow-up. Radiopaque indicators (arrows) at

\* Corresponding author. *E-mail address:* rita.d.faria@gmail.com (R. Faria). the edges of the scaffold were the only discernible traces on volume-rendered imaging (Figure 1B) and in maximum intensity projection reconstructions (Figure 1C).

Virtual histology (Aquarius workstation, TeraRecon Inc., San Mateo, CA) showed the non-calcified atherosclerotic plaque (arrows) excluded by the stent (Figure 1D). Cross-sectional in-stent lumen areas were measured, with a minimal lumen area of 5.54 mm<sup>2</sup>. No significant lumen loss was detected.
